Manhole Inspection Summary

Manhole # S21C__005MH

Insp Date: **10/17/07 10:34 AM**

Location Address: **1821 LAURETTA AVE**

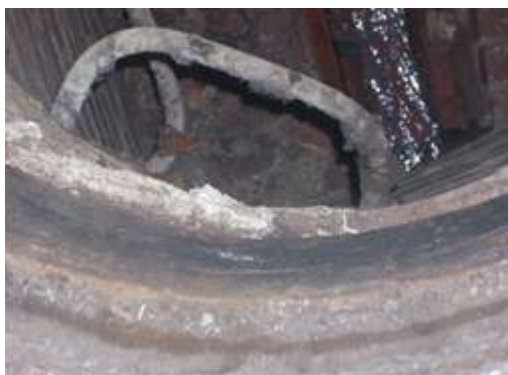
Defect 1

Frame Offset: **1** (in.) Condition: ☒ Sound ☐ Cracked ☐ Leaks

Condition: ☐ Sound ☐ Cracked ☐ Root Intrusion ☐ Loose Brick ☒ **Deteriorated**

FRAME OFFSET AND DETERIORATED
CHIMNEY

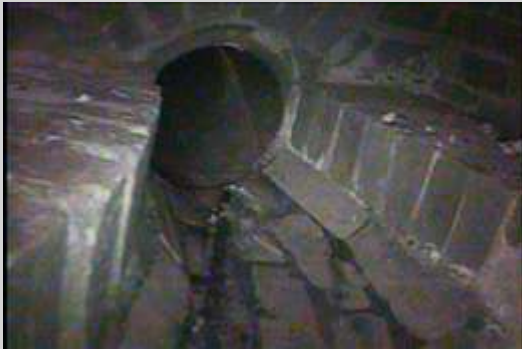
12 O'Clock Outflow

8 in. Circular Gravity Sewer
Pipe Out @ 12 O'Clock

Pipe Height: **8.4** (in.) Rod and Bar (Angled)
Pipe Material: **Clay** ☐ Pipe Lined
Invert Depth: **5.86** (ft.) Flow Characteristics: **Slow**
Deposits: ☒ None ☐ Mud ☐ Sludge ☐ Debris ☐ Grease
Silt Depth: (in.) Deposits Extent:
Infiltration: **None** Pipe Seal Cond: **Sound**

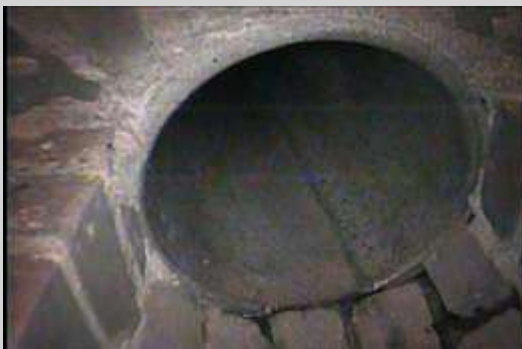
6 O'Clock Inflow

8 in. Circular Gravity Sewer
Pipe In @ 6 O'Clock

Pipe Height: **7.2** (in.) Rod and Bar (Angled)
Pipe Material: **Clay** ☐ Pipe Lined
Invert Depth: **5.42** (ft.) Flow Characteristics: **Slow**
Deposits: ☒ None ☐ Mud ☐ Sludge ☐ Debris ☐ Grease
Silt Depth: (in.) Deposits Extent:
Infiltration: **None** Pipe Seal Cond: **Sound**
